Leak Callout - Roof Repair

Stansted Police Station

Essex County Council

Roof Leak | Vandalism | Roof Repairs

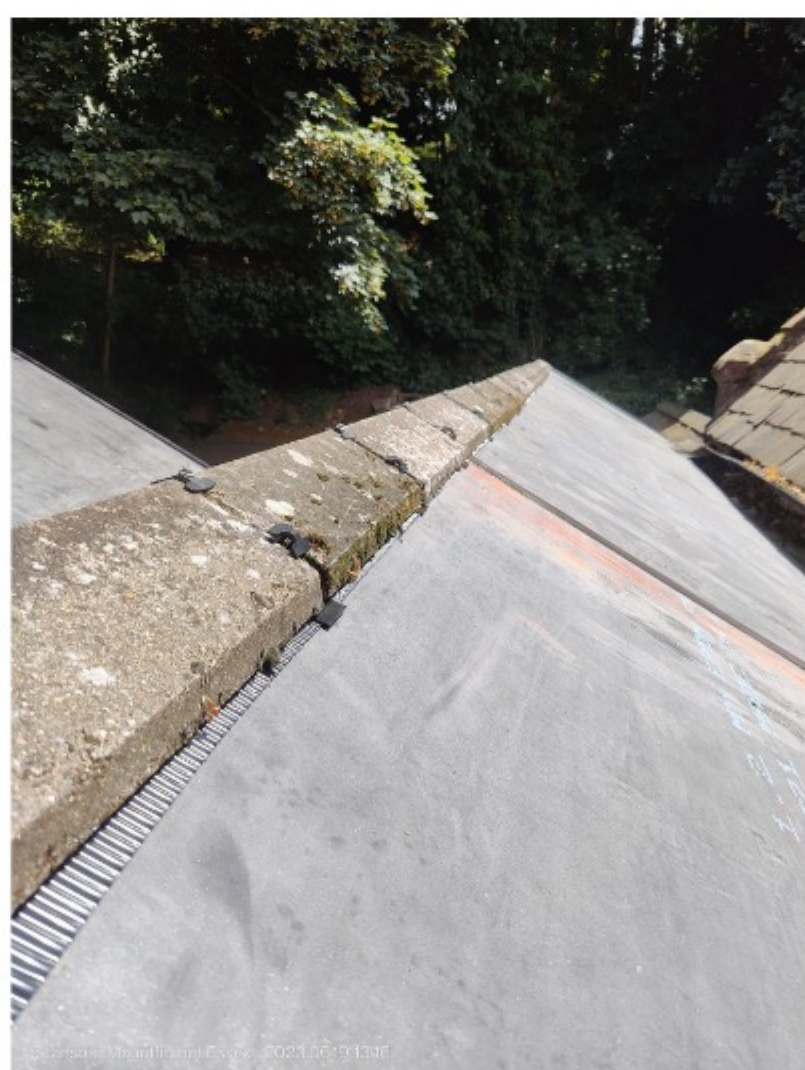
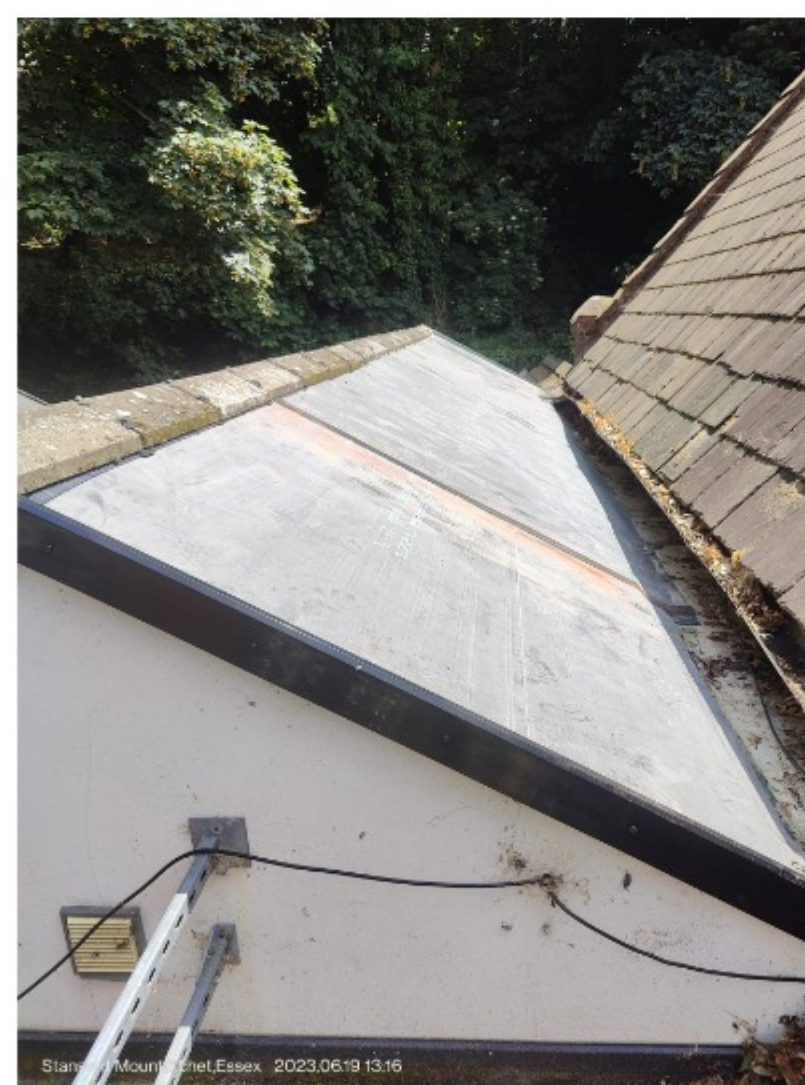
Responsive Maintenance: An emergency call-out was requested following a roof leak at the site. SDE operatives responded within the hour, identifying that the issue was caused by a combination of vandalism and existing defective weathering, with lead stolen from the roof. This rapid response ensured the problem was assessed promptly to minimise disruption and a recovery plan in place urgently.

Implementing Solutions: To prevent further damage to the building's interior and maintain its occupancy, SDE installed a temporary weatherproof solution. This immediate action mitigated additional issues while allowing time to develop a permanent solution in full collaboration with the client. SDE worked closely with stakeholders to identify measures that would prevent the recurrence of similar incidents.

Handover and Long-Term Support: After thorough discussions with the client, SDE was instructed to replace the valley section of the roof with a durable and cost-effective solution. The works involved removing the existing tiled roof, reforming the roof structure, and installing a robust rubber system with associated ridge and junction detailing. This approach ensured long-term durability while offering value for money, providing the client with a sustainable solution to prevent future issues.
